THE **BOEING** COMPANY
AERO-SPACE DIVISION
SATURN BOOSTER BRANCH

DOCUMENT NO. T5-6539-104

TITLE Failure Analysis of Actuator Boot Fittings

MODEL NO. Sat. V/S-IC CONTRACT NO. NAS8-5608

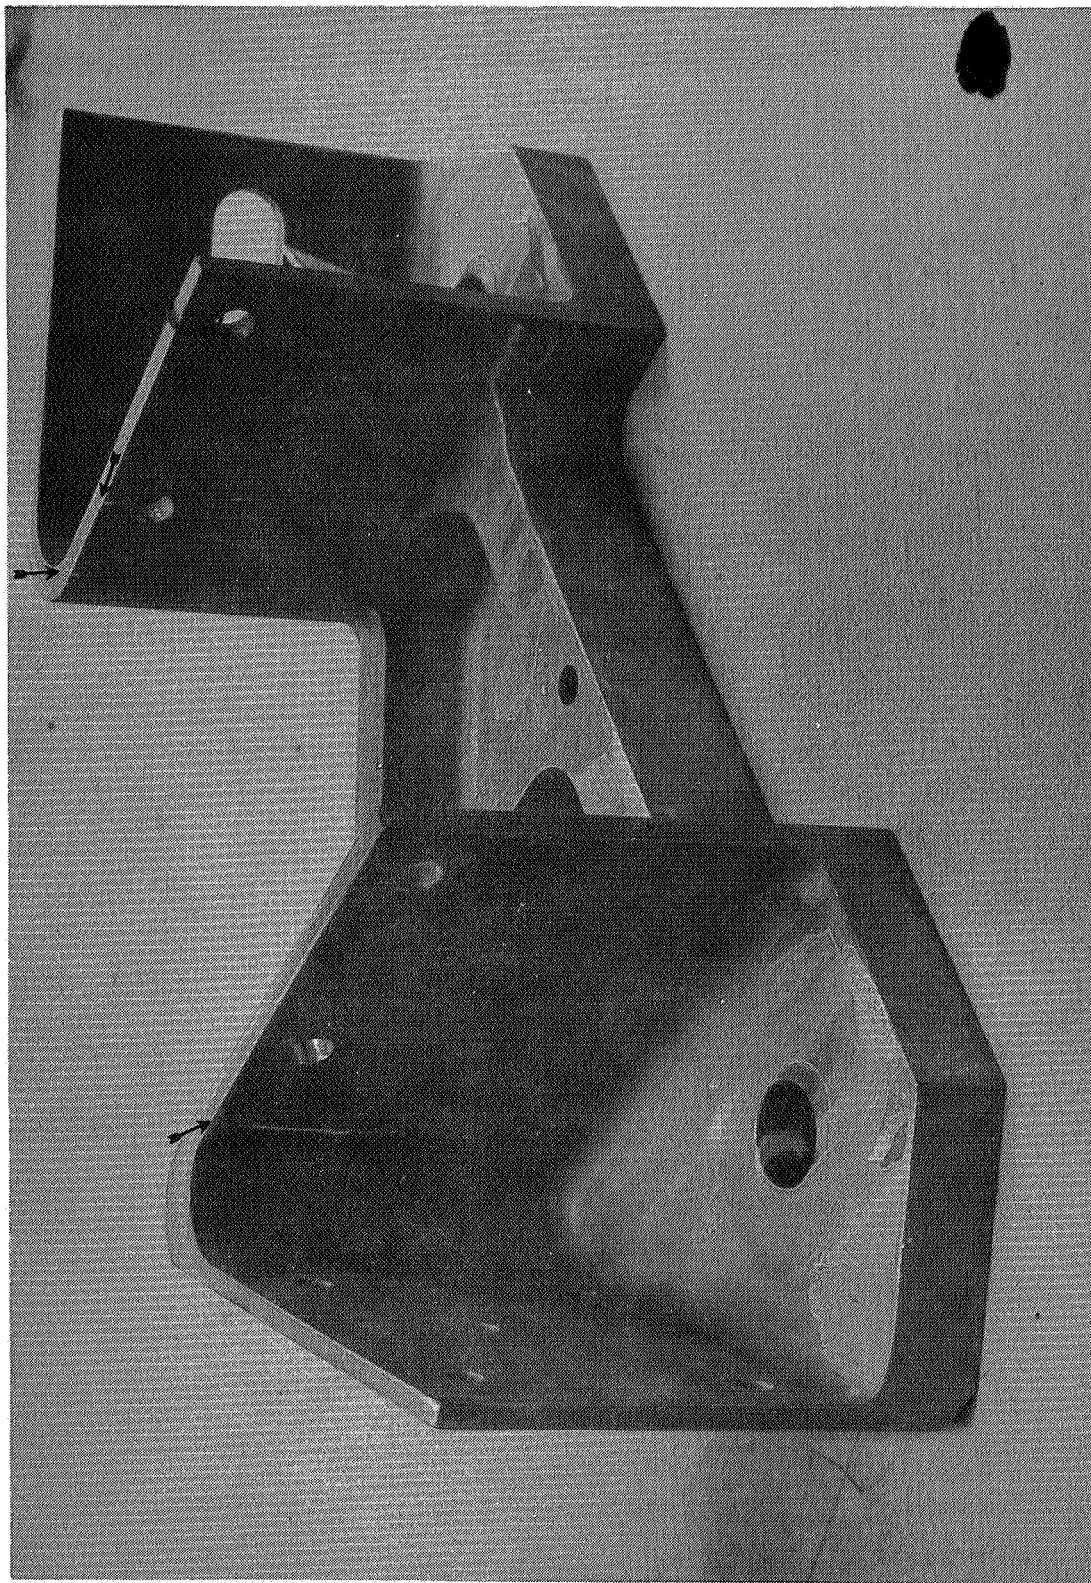
- 3.0 Conclusions. - High tensile installation stresses resulted from poor fit-up on assembly and were probably in excess of the stress corrosion threshold stress of 7079-T6 aluminum alloy. The combination of these sustained tensile loads and atmospheric exposure caused stress corrosion cracking of the boot fittings.

- 5.0 Procedures and Results. - On receipt, the fittings were dye penetrant inspected. The results of this inspection are evident in figures 2 and 3 for -1 and -2 parts respectively. Arrows indicate the crack locations at the inner bolt holes and near the machined radii.

Figure 2 Part Number 60B21146-1 Crack Indications ~ 1/2 size

- 4.0 Recommendations. - The reduction of installation preloads will reduce the possibility of stress corrosion cracking. However, to negate all possibility of this type of cracking a more stress corrosion resistant alloy, such as 7075-T73, should be considered in the future.

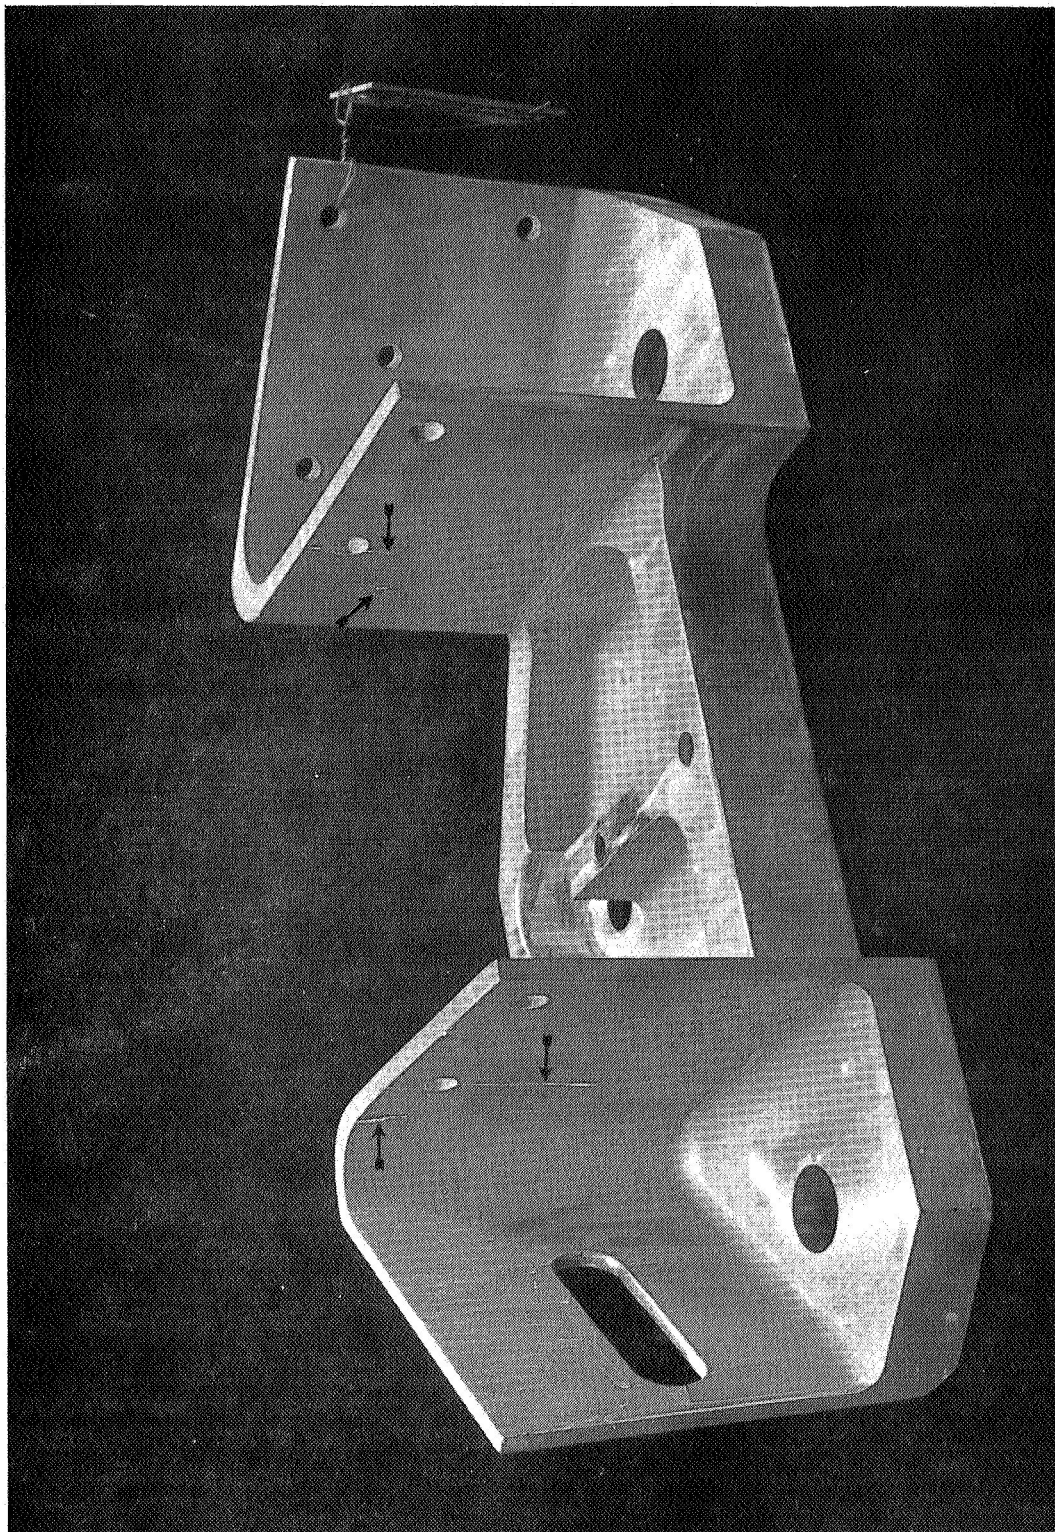
Figure 3 Part Number 60B21146-2 Crack Indications ~ 1/2 size

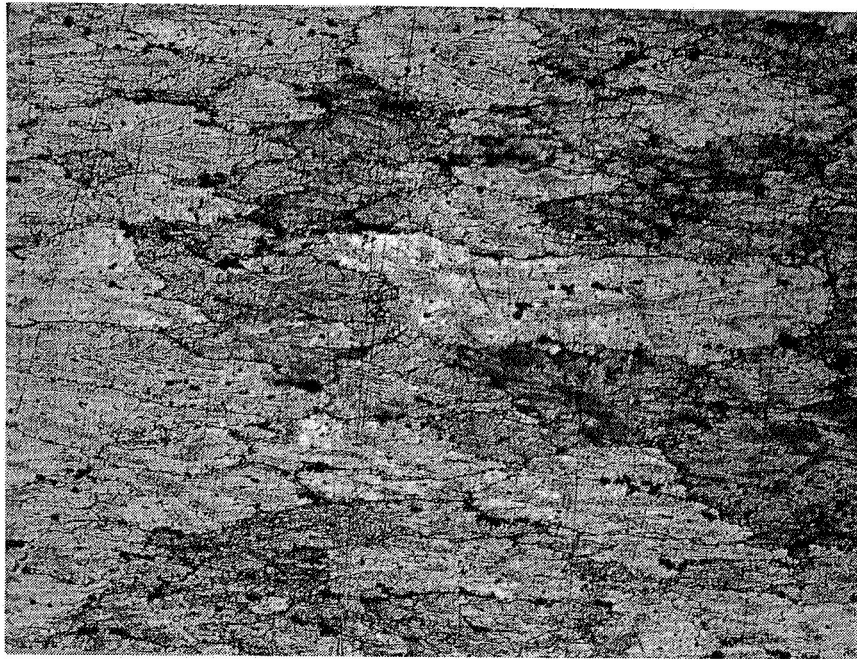
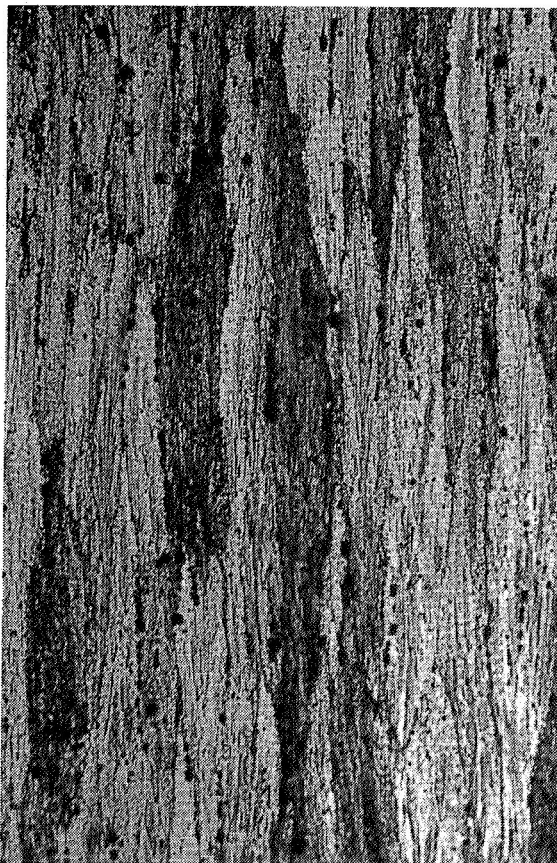
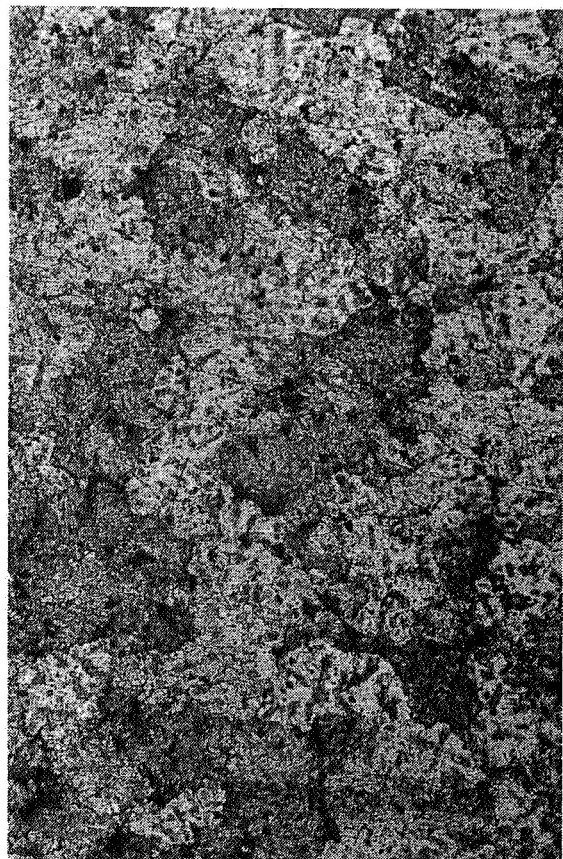
Figure 4 Forging Grain Directions

The grain direction required by drawing number 60B21146 was confirmed in each part by macroscopy and is illustrated in figure 4 as typical for each part.

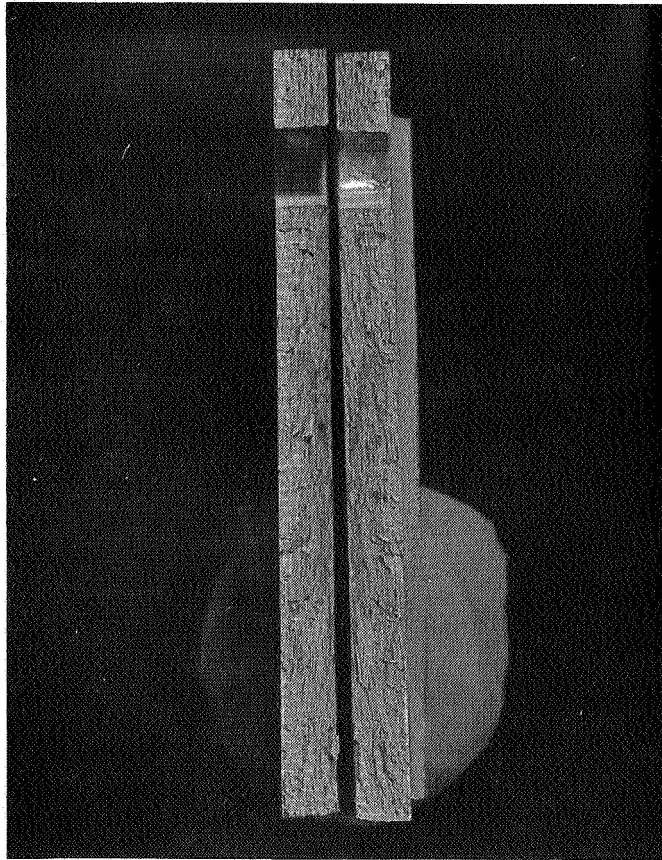
Figure 5 shows the fracture faces of one crack taken from the 60B21146-1 part and is again typical of all other cracks examined in both -1 and -2 parts. The faces exhibit an exfoliated appearance. Figure 6 is a micrograph of a cross section taken at one edge of this fracture. Note the branching nature of the crack. The lower photograph is an enlargement of the indicated zone in the top photograph. Figure 7 is a micrograph taken of a longitudinal section. Though the intergranular paths of the cracking found in this investigation were not as dramatic or classical as in other cases, sufficient evidence was provided to attribute the failures to stress corrosion cracking.

Figure 5 Fracture Faces of One Crack $\approx 1.5X$
